GLENCORE'S OIL OPERATIONS IN CHAD:

LOCAL RESIDENTS INJURED AND IGNORED

March 2020

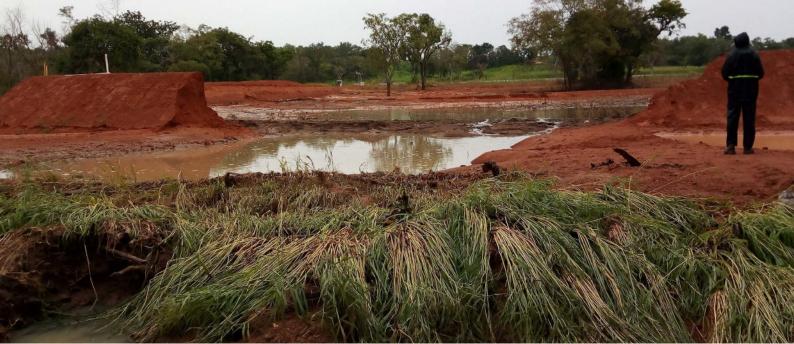
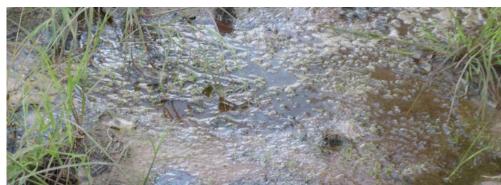
Destruction caused by the wastewater spill on 10 September 2018.

That night the earth bank supporting the water basin collapsed and a wave of destruction swept across the surrounding landscape until the wastewater poured, unchecked, into the local Nya Pende River. The river was crucial for daily life. Thousands of downstream local residents used it for bathing, fishing, washing and to water livestock and crops.

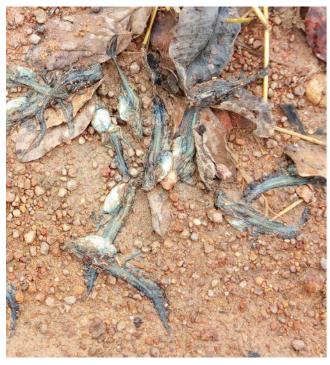
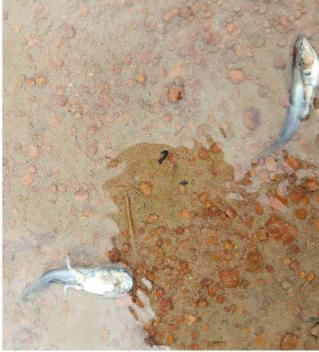
Floating dead fish in the river on the day of the watewater spill on 10 September 2018.

Photos taken on the day of the wastewater spill show oil traces and dead fish floating on the surface of the water. One local resident said: "When the dam ruptured, all the fish died but Glencore never told us [about it] and we ate the dead fish."54

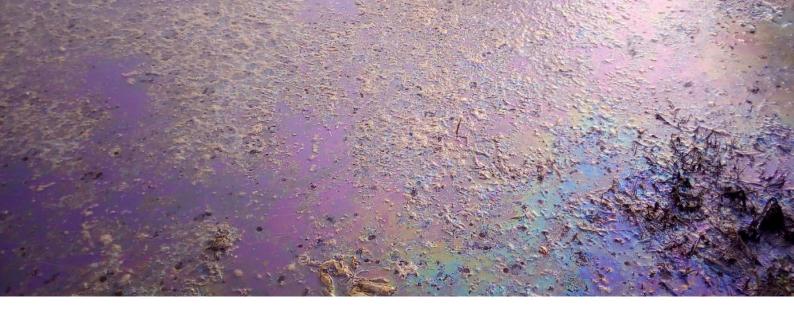
Appearance of oil traces on the river surface, May 2019.

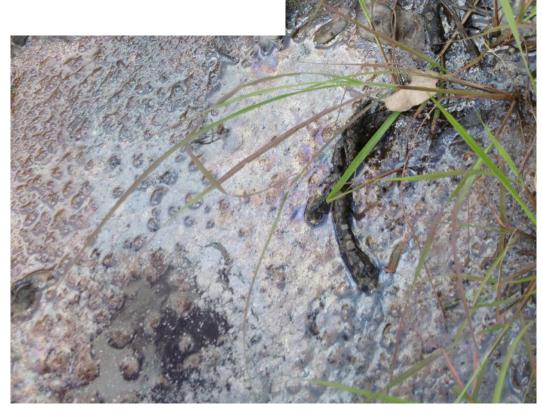
Appearance of oil traces following wastewater spill, 10 September 2018"

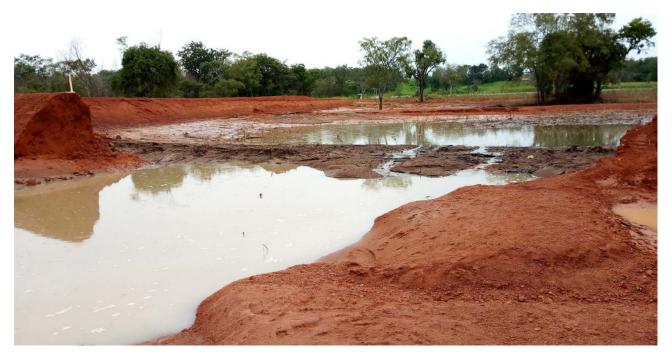
Wastewater rupture, 10 September 2018

Glencore should have built the wastewater basin to withstand heavy tropical rain. When the earth banks supporting the basin began to leak, Glencore should have used all means necessary to repair the damage and avoid the spill.

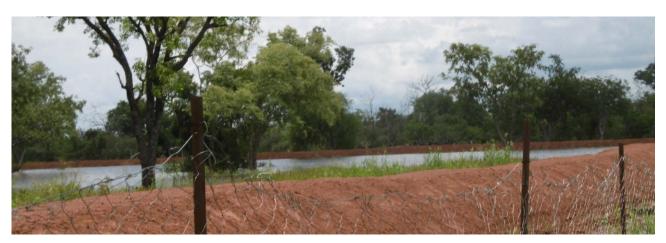
Wastewater basin, August 2018.

In August 2018, in the midst of the rainy season in Chad, the pressure on the basin berms increased and the basin began to leak. According to two local customary chiefs, on 18 August, Glencore sought to convince communities to agree to a controlled release of the water into the river,²⁷ a request that was refused. Local customary chiefs interviewed by RAID said they had refused as Glencore provided no proof that the wastewater was harmless or that the Chadian Minister of the Environment had agreed to it. On 19 August 2018 a local civil society group, AJTZP, issued a press release,28 urging PCM and Glencore to address the situation. Glencore did not respond.
